Name Of Dam: LAKE MONTCLAIR DAM
Location: PRINCE WILLIAM COUNTY
Inventory Number: VA. 15302

PHASE I INSPECTION REPORT

Lake Montclair Dam. Inventory Number:
VA-15302. Prince William County, Virginia.
Phase I Inspection Report.

MARCH 1979

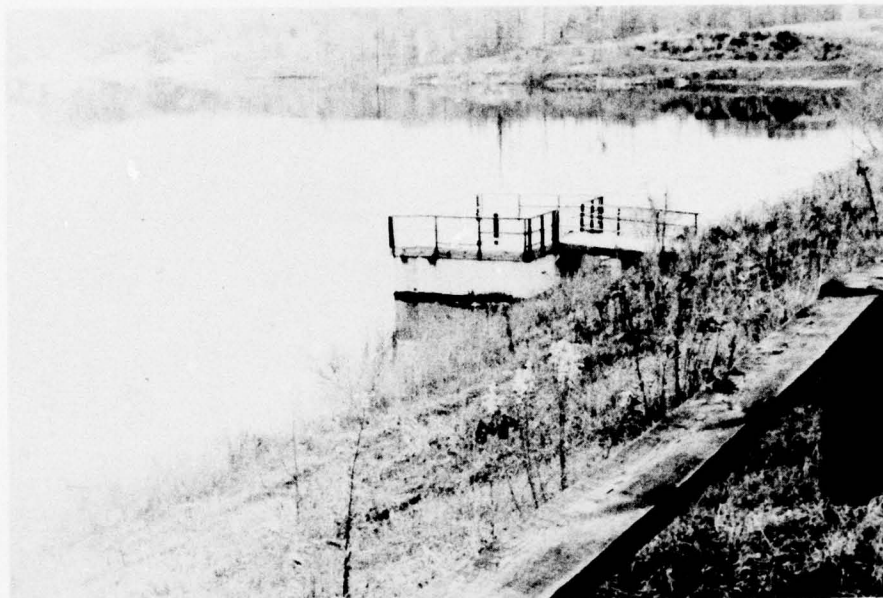
PHOTOGRAPH NO. 1
Principal Intake Structure

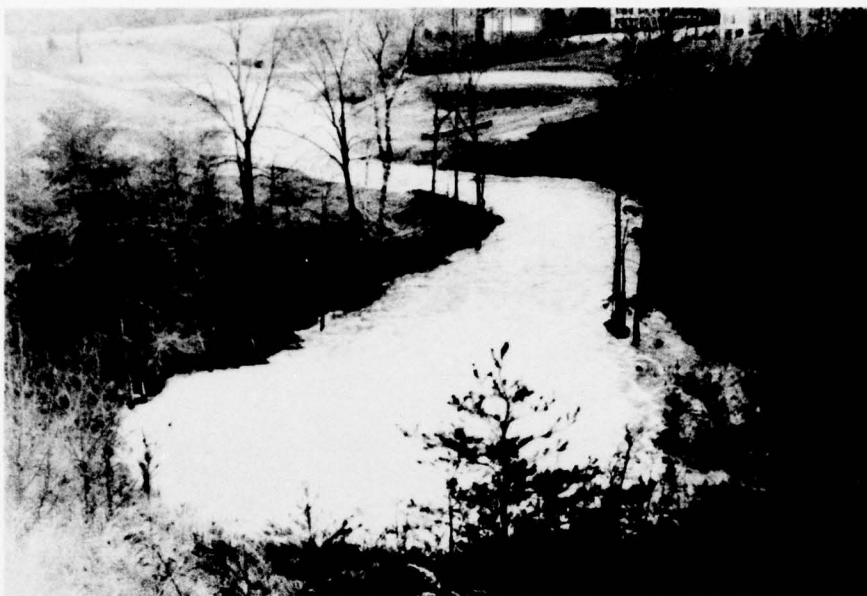
PHOTOGRAPH NO. 3
Discharge Channel

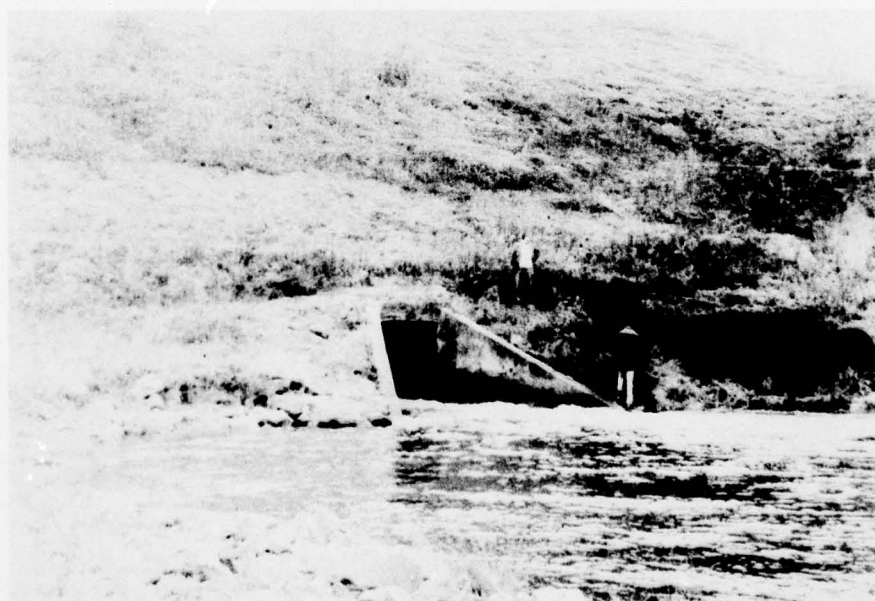
PHOTOGRAPH NO. 6
Wing Wall Discharge Box
